**4220 BAXTER ROAD
ANCHORAGE, ALASKA**

PHASE I ENVIRONMENTAL SITE ASSESSMENT

JUNE 2024

Submitted to: Cook Inlet Housing Authority
3510 Spenard Road, Suite 100
Anchorage, Alaska 99503

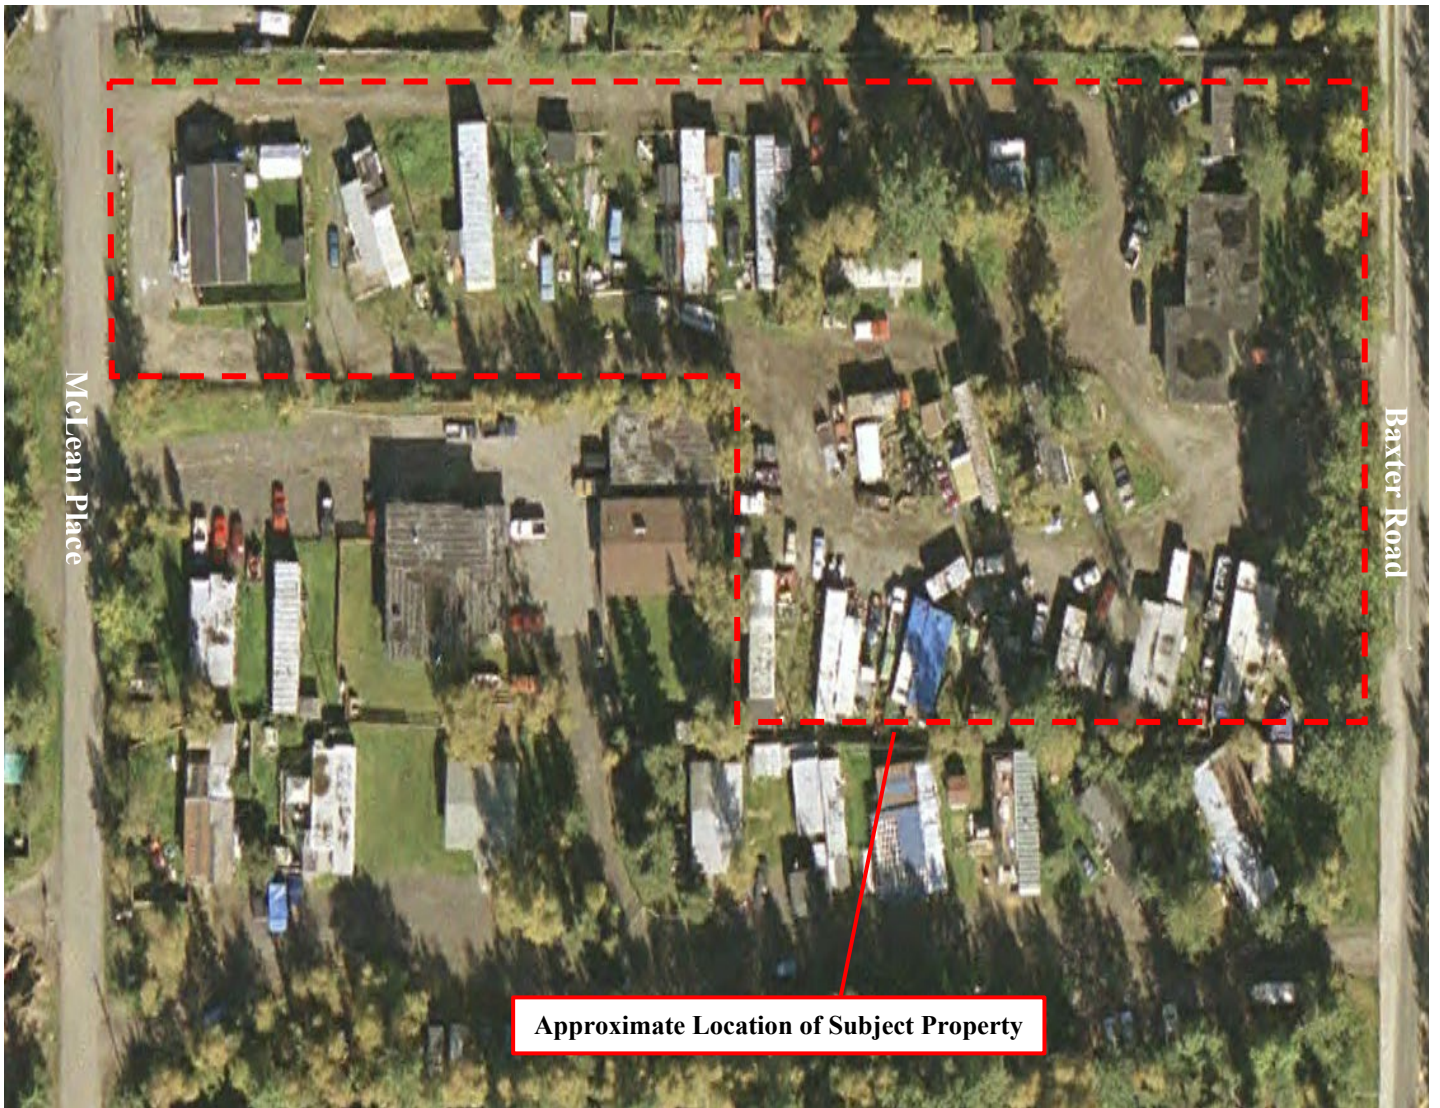
BGES, INC. <small>ENVIRONMENTAL CONSULTANTS</small>	June 2024	Figure 4

The August 31, 2002 aerial photograph, included as Figure 4, showed the subject property as containing several mobile homes, buildings that appeared to be single-family homes near the east and west ends of the property; and numerous sheds, parked vehicles, and indiscernible items and debris surrounding the mobile homes and residential structures on the property. Similar (in appearance) trailers and residential buildings were present on the lot adjacent to, and south of, the subject property. The majority of the surrounding area was similar in appearance to what was observed in the 1996 aerial photograph, with a notable exception being a lot approximately 250 feet to the southwest of the subject property (at the northwest corner of the intersection of McLean Place and East Tudor Road), which had been cleared of vegetation and structures, and was undergoing significant earthwork. This was being done in advance of the construction of 18 duplexes that would be constructed on this lot by the following year.

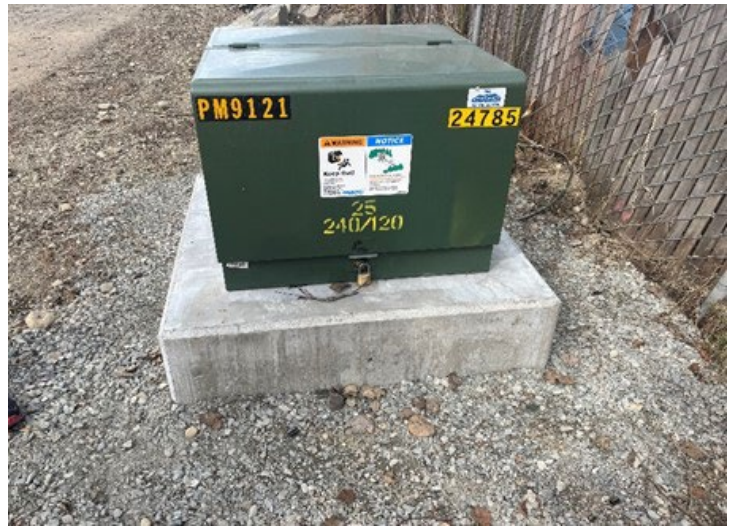
A pad-mounted transformer was present along the north edge of the subject property (Photographs 1 and 2 in Appendix B). No overt evidence of releases was noted in association with the transformer. The northeast corner of the subject was very flat with sparse vegetation and trees. Construction materials including pipes and concrete blocks are present in this corner of the property (Photograph 3 in Appendix B). The eastern side of the property had braided wiring protruding from the ground, the nature of which is unknown (Photograph 4). A portion of a cutoff pipe that had been mounted in cement was located on the northwest portion of the property, and was located adjacent to some boulders (Photograph 5 through 7 in Appendix B).

A pad-mounted transformer was present at the subject property; however, no overt evidence of releases having occurred in association with this transformer was noted at the time of our site reconnaissance.

Photo 2. Pad-Mounted Transformer Along N Side of Property

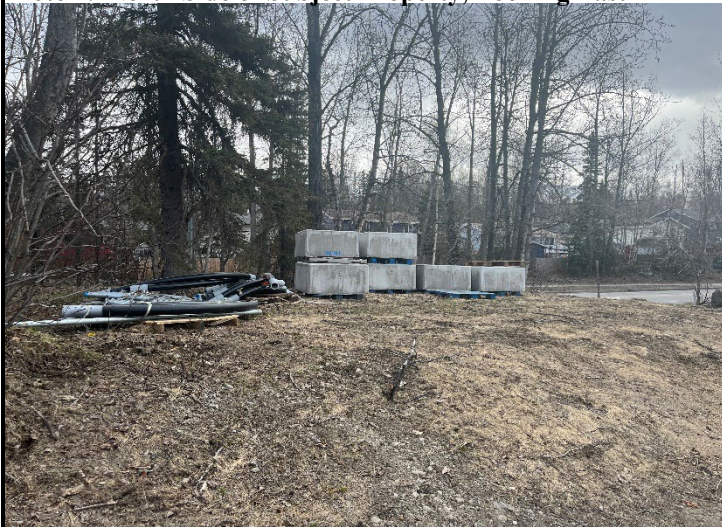
Photo 3. Pipes and Concrete Blocks, Looking East

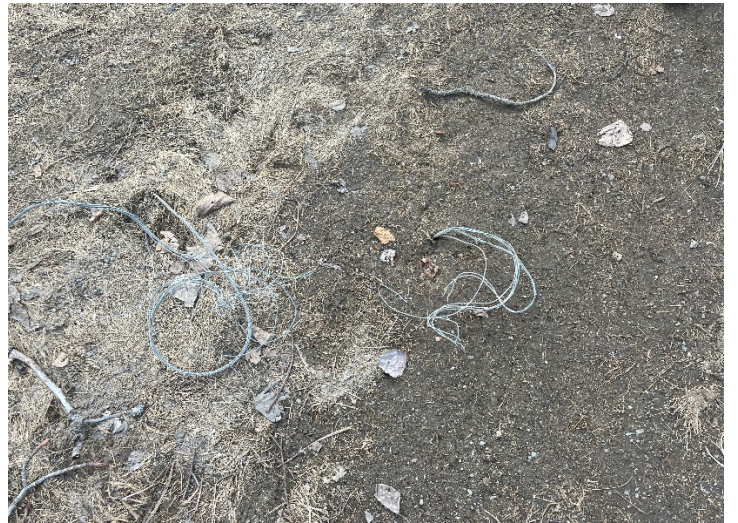
Photo 4. Wiring on East End of Subject Property

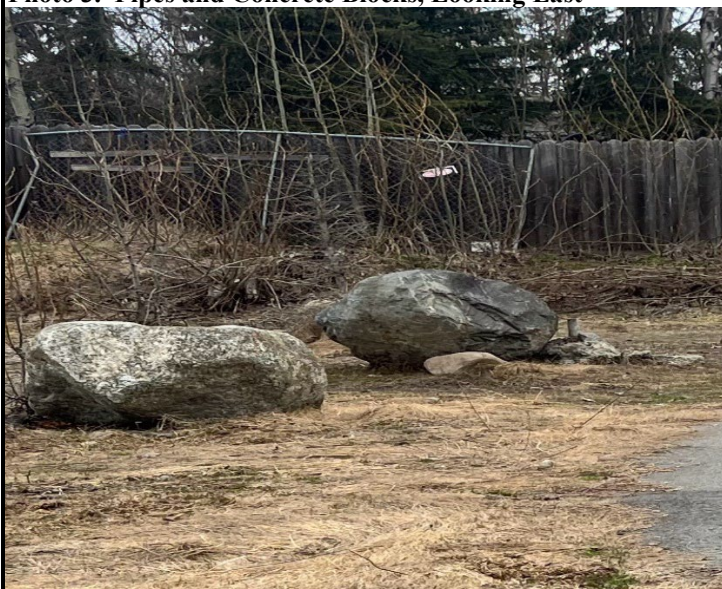
Photo 5. Pipe and Boulders at NW Corner of Subject Property

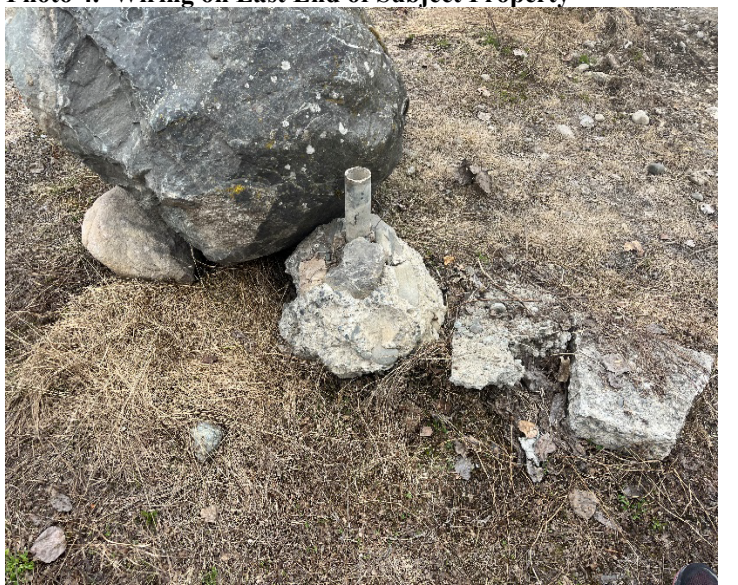
Photo 6. Discarded Cement Blocks and Pipe

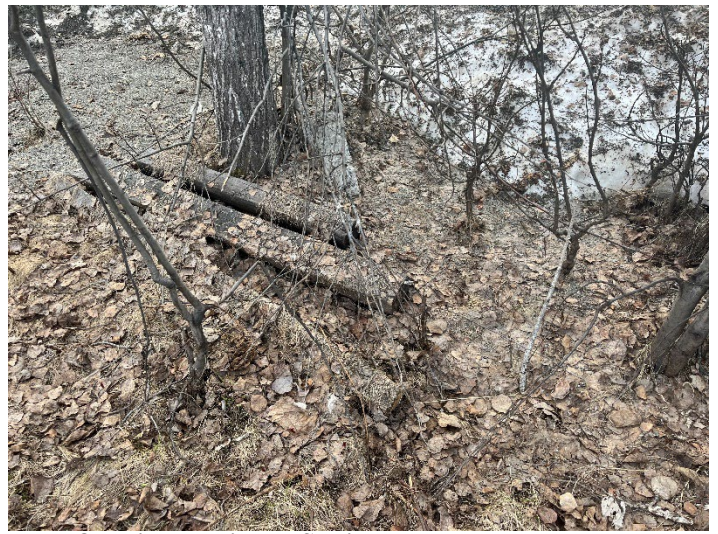
On the southern portion of the subject property were three railroad ties (Photograph 8 in Appendix B), which may be treated with creosote. No staining on the surrounding ground surface was noted. What appeared to be a septic vent/cleanout pipe was located on the southwest portion of the property (Photograph 9 in Appendix B). A pile of snow and gravel was present on the southeast portion of the lot (Photograph 10 in Appendix B).

Photo 8. Railroad Ties on Subject Property

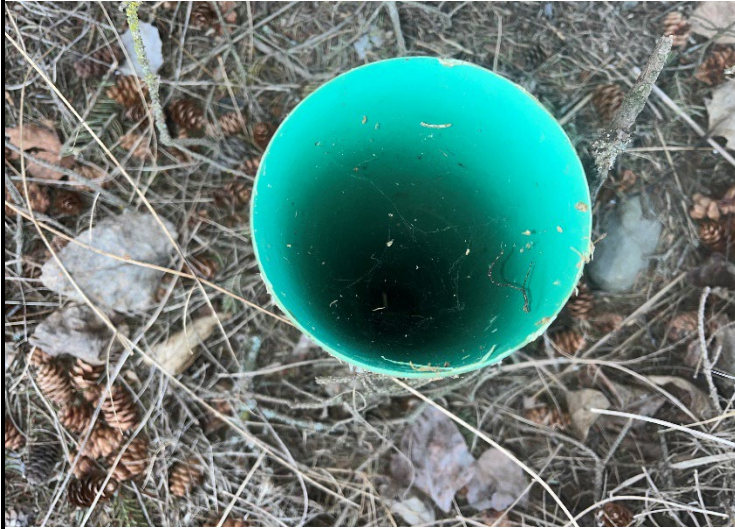
Photo 9. Possible Septic Vent Pipe

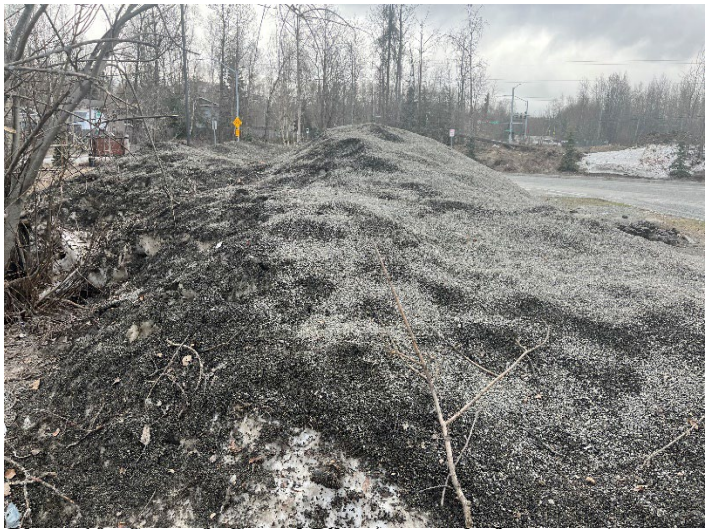
Photo 10. Snow & Gravel Piles (east end of property)

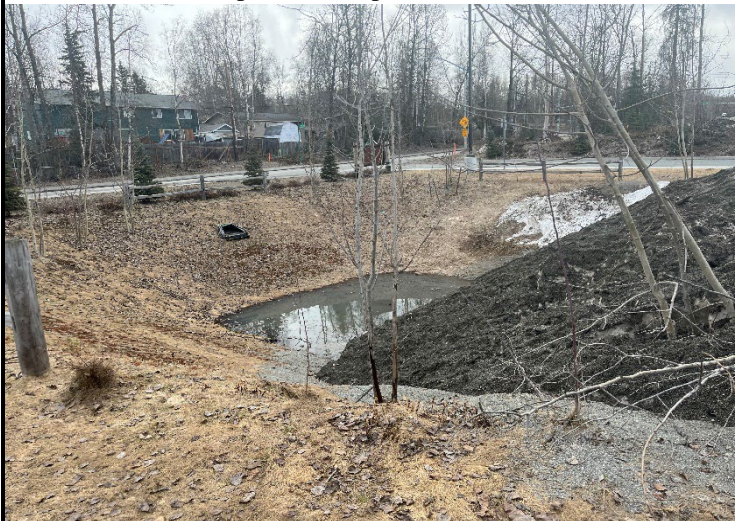
The area surrounding the subject property was mostly comprised of residential properties. The Baxter Senior Living facility is adjacent to, and south of, the subject property. This property contained what appeared to be a drainage collection/settling pond, and the surface of the water exhibited a sheen at the time of our reconnaissance; however, the sheen appeared to be biogenic (as opposed to petroleum-based) in nature. While there would be an increased potential for contaminants to drain into this pond via surface water drainage through an observed drainpipe that extends to the east beneath Baxter Road, it is likely that any such contaminants would be greatly diluted by the water, and this would decrease the potential for these contaminants to migrate to the subject property in a significant way. It is therefore not considered to represent a recognized environmental condition for the subject property. No other evidence of

Photo 11. Drainage Pipe and Apparent Settling Pond, Looking SE

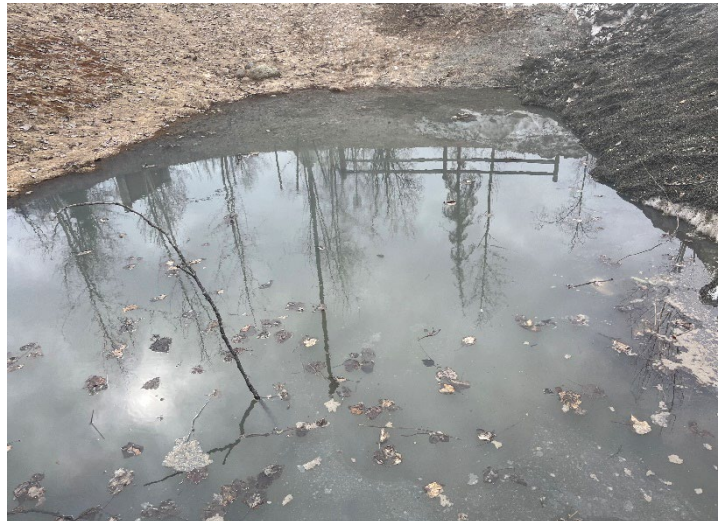
Photo 12. Apparent Biological Sheen/"Scum" on Settling Pond
