**4220 BAXTER ROAD
ANCHORAGE, ALASKA**

PHASE I ENVIRONMENTAL SITE ASSESSMENT

JUNE 2024

Submitted to: Cook Inlet Housing Authority
3510 Spenard Road, Suite 100
Anchorage, Alaska 99503

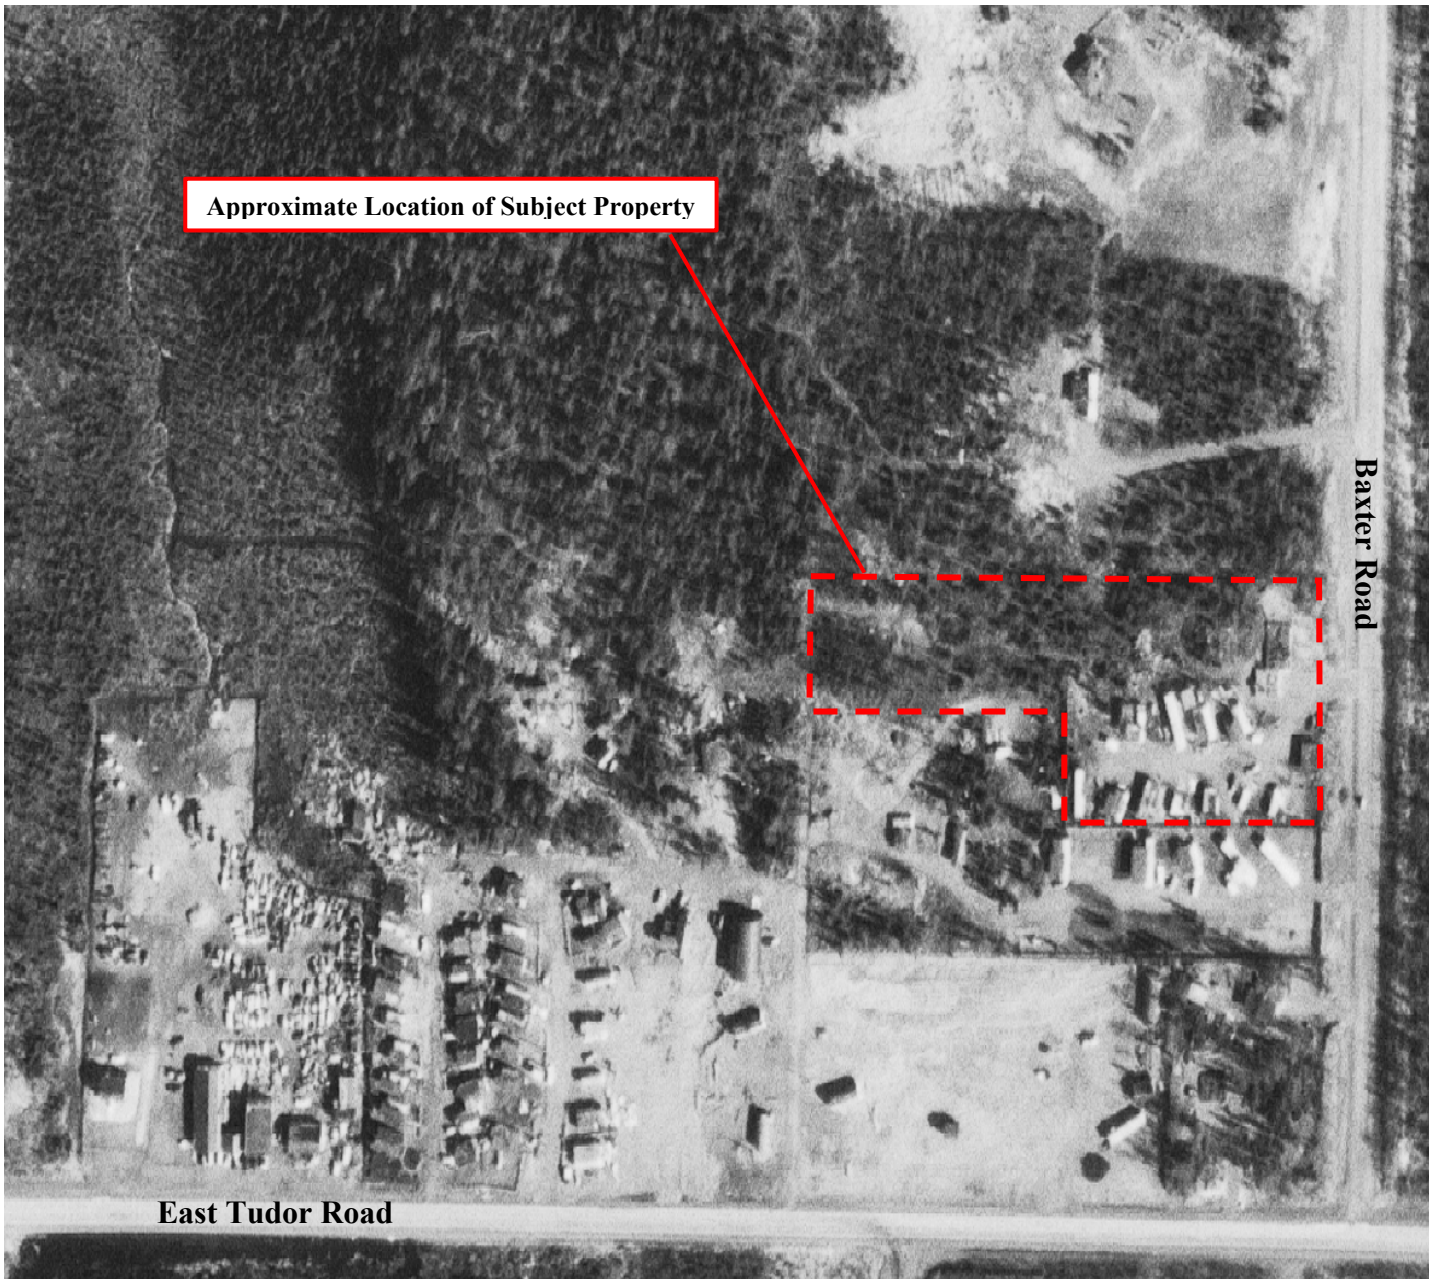
The May 17, 1962 aerial photograph, included as Figure 2 showed the subject property as containing several mobile homes and what may be a couple of small permanent structures in the southeast portion of the property. Some indiscernible items are also present in the western portion of the properties, among the trees. The remainder of the property appeared to be undeveloped and covered with vegetation. Additional mobile homes and residential buildings are present to the south and west of the subject property, and more residential development is present further to the south and southwest, along East Tudor Road. A single residential building was present on the land adjacent to and north of the subject property, and Baxter Road was visible to the east of the property. What may have been some gravel mining appeared to have been occurring further to the north.

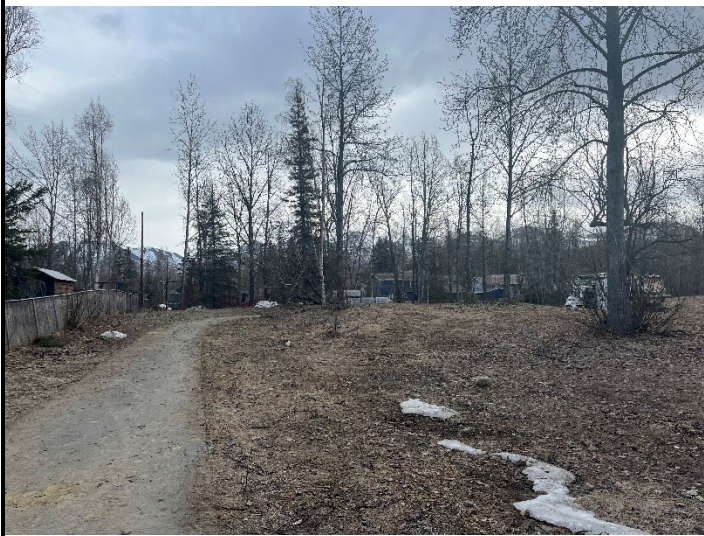
Photo 1. North Side of Subject Property, Looking East

A pad-mounted transformer was present along the north edge of the subject property (Photographs 1 and 2 in Appendix B). No overt evidence of releases was noted in association with the transformer. The northeast corner of the subject was very flat with sparse vegetation and trees. Construction materials including pipes and concrete blocks are present in this corner of the property (Photograph 3 in Appendix B). The eastern side of the property had braided wiring protruding from the ground, the nature of which is unknown (Photograph 4). A portion of a cutoff pipe that had been mounted in cement was located on the northwest portion of the property, and was located adjacent to some boulders (Photograph 5 through 7 in Appendix B).

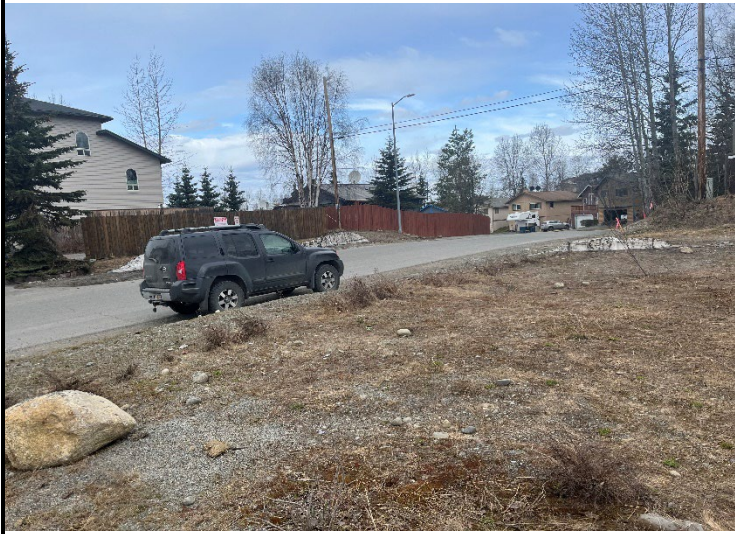
Photo 7. Northwest Portion of Property, Looking Northwest

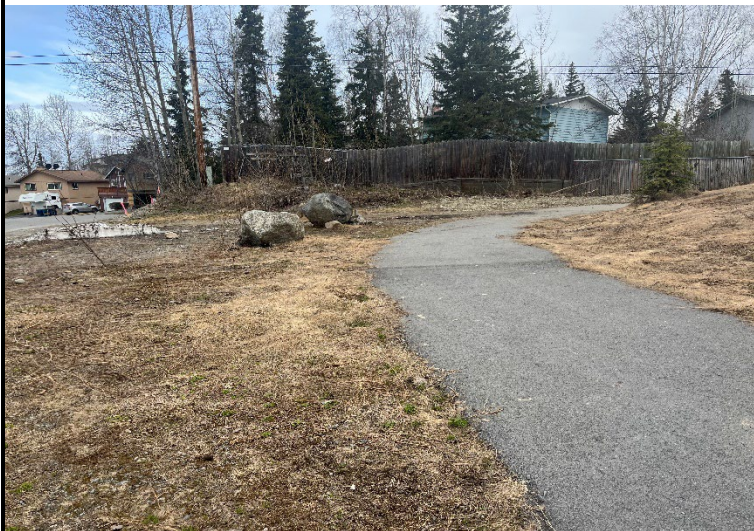
The subject property was bordered by Eastwood Court to the north, McLean Place to the, and Baxter Road to the east (Photographs 13 through 15 in Appendix B). Baxter Senior Living LLC and its associated parking lot bordered the subject property to the south and southwest.

Photo 13. View of Eastwood Court, Looking North

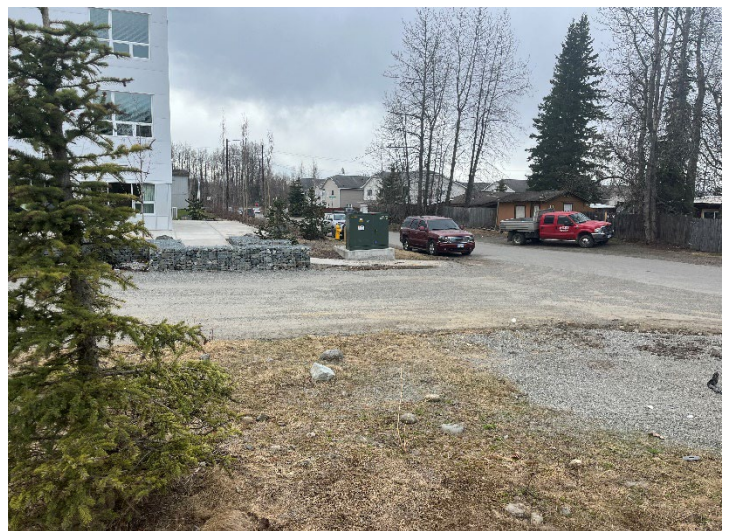
Photo 14. View of McLean Place, Looking Southwest

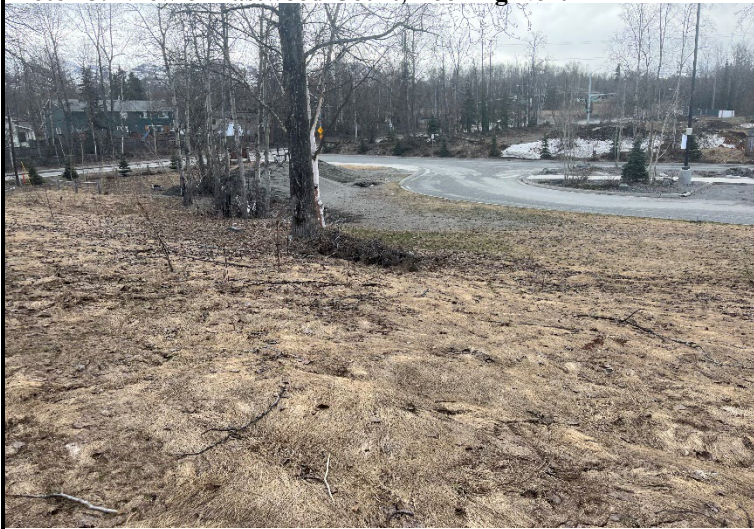
Photo 15. View of Baxter Road, Looking East
